200753 – AIS R1 Wix-Brown Elementary

**Reference:** Asbestos Inventory Survey of Wix-Brown Elementary, 23851 – 24<sup>th</sup> Avenue, Langley, BC

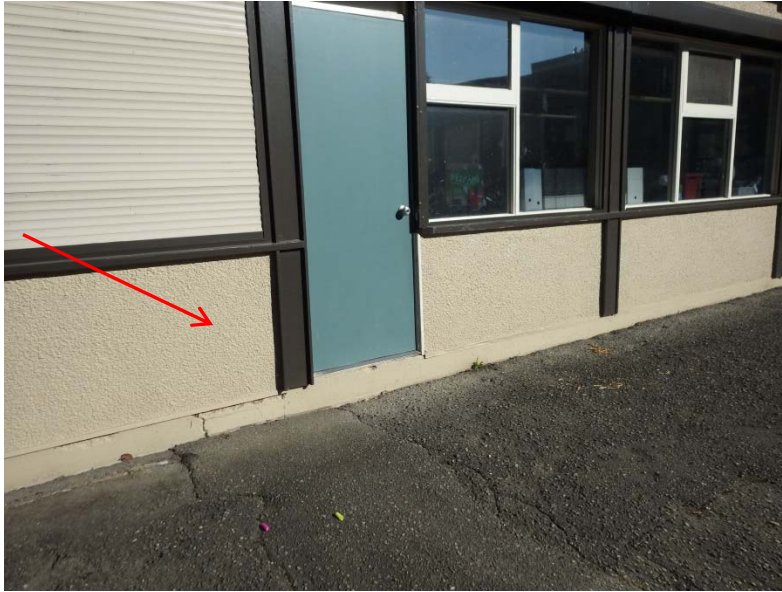
One (1) sample of large stucco outside Room 24 was collected in 2006 and found to be non-containing. The present survey collected three (3) additional samples and one (1) sample was found to contain 1% chrysotile asbestos (West wall outside Rm 19). Total Safety recommends that additional samples of stucco are collected and analyzed prior to any disturbance.

<b>Photo 1</b>	<b>Date:</b> Sept. 12, 2016	<b>Location:</b> West Exterior Wall outside Room 19
<b>Description:</b> Stucco

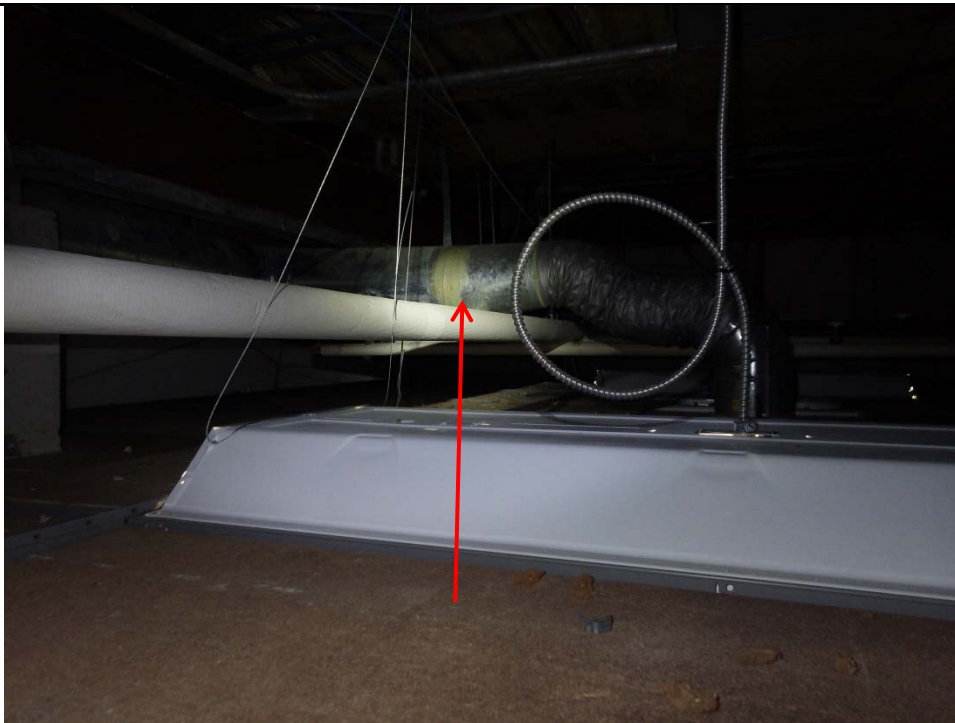
One (1) sample of gray/green duct sealing mastic was collected during the present survey and found to be asbestos containing. Total Safety recommends that all gray/green duct sealing mastic in the school be considered to be asbestos containing.

<b>Photo 2</b>	<b>Date:</b> Sept. 12, 2016	<b>Location:</b> Storage Room B2
<b>Description:</b> Gray/Green Duct Mastic

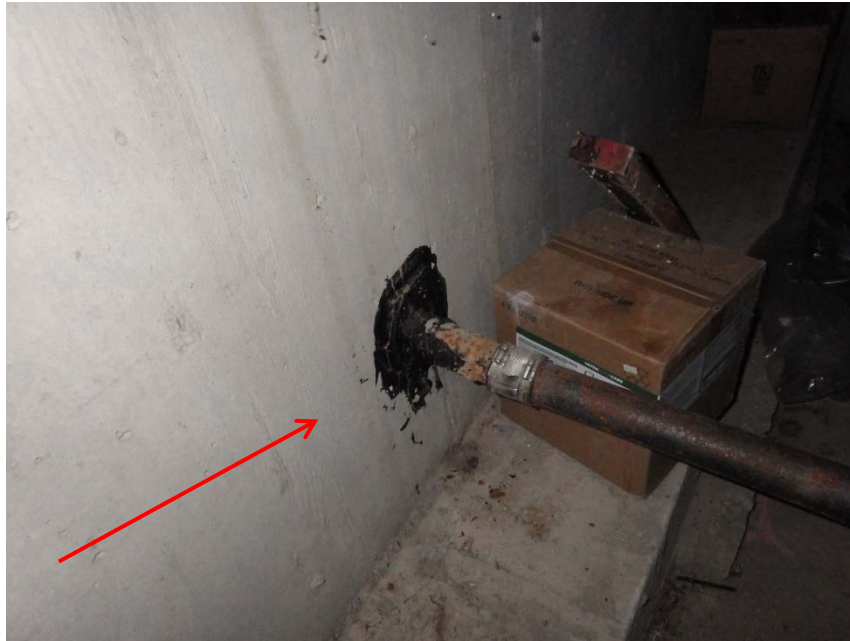
One (1) sample of black mastic was collected from a water pipe during the present survey and was found to be asbestos containing. Total Safety recommends that all black sealing mastic present on water pipes in the school be considered to be asbestos containing.

<b>Photo 3</b>	<b>Date:</b> Sept. 12, 2016	<b>Location:</b> Crawlspace under Library
----------------	-----------------------------	---

<b>Description:</b> Black sealing mastic on water pipe
--

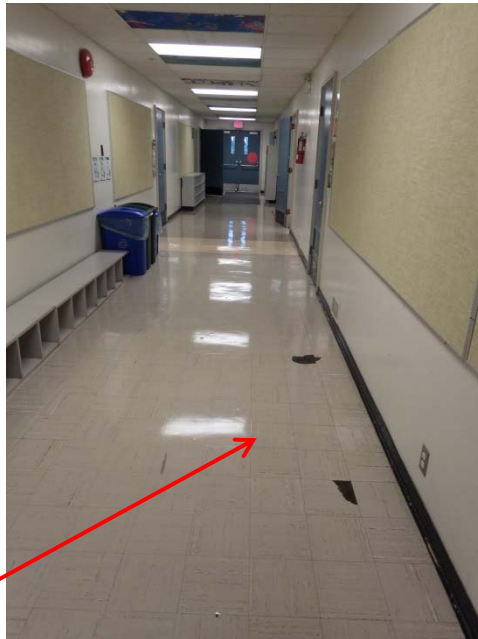
Off-white 12x12 floor tile	(2006) – 1 (2016) – 0	• Gym Kitchen and Supply Room 4	• Still present, original sample in Gym Kitchen
White (beige) 9x9 floor tile	(2006) – 1 (2016) – 1	• Corridor outside Room 19	• Still present, two tiles chipped, Photo 4

White (beige) 9" x 9" floor tile identified by the 2006 survey is still present in the corridor outside Room 19. During the present survey a second sample was collected and this sample confirmed the presence of asbestos. It was noted that two floor tiles had large sections missing. Total Safety recommends that all similar 9" x 9" floor tile in the school be considered to be asbestos containing.

<b>Photo 4</b>	<b>Date:</b> Sept. 12, 2016	<b>Location:</b> Corridor outside Room 19
----------------	-----------------------------	---

<b>Description:</b> Beige 9" x 9" floor tile
--
